# 3M™ Ketac™ Cem Plus

Resin Modified Glass Ionomer Cement  
SIX-YEAR CLINICAL PERFORMANCE

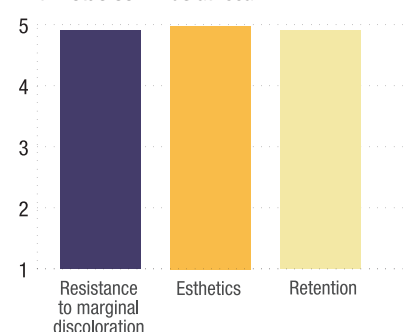
Fig. 4: Clinical results of restorations cemented with **Ketac Cem Plus** at recall.

Resistance to marginal staining was rated as excellent - 97 of 100 restorations received a rating of 5 (Figure 4). Of the remaining three restorations, one had marginal caries and two had marginal discoloration.

Esthetics was rated as excellent, with 99 restorations receiving a 5 and one restoration receiving a 4 (the restorative material was slightly dull) (Figure 4).

Retention was rated as excellent (Figure 4). During the recall period, 3 of 100 restorations debonded. However, one debond occurred while an elevator was being applied to an adjacent tooth. Two debonds occurred spontaneously. All three restorations were recemented.
